CSD/NPIC 402/65

5 JANUARY 1965

HIGHWAY BRIDGE, ROUTE 9
TCHEPONE AREA, LAOS
1642N 10613E

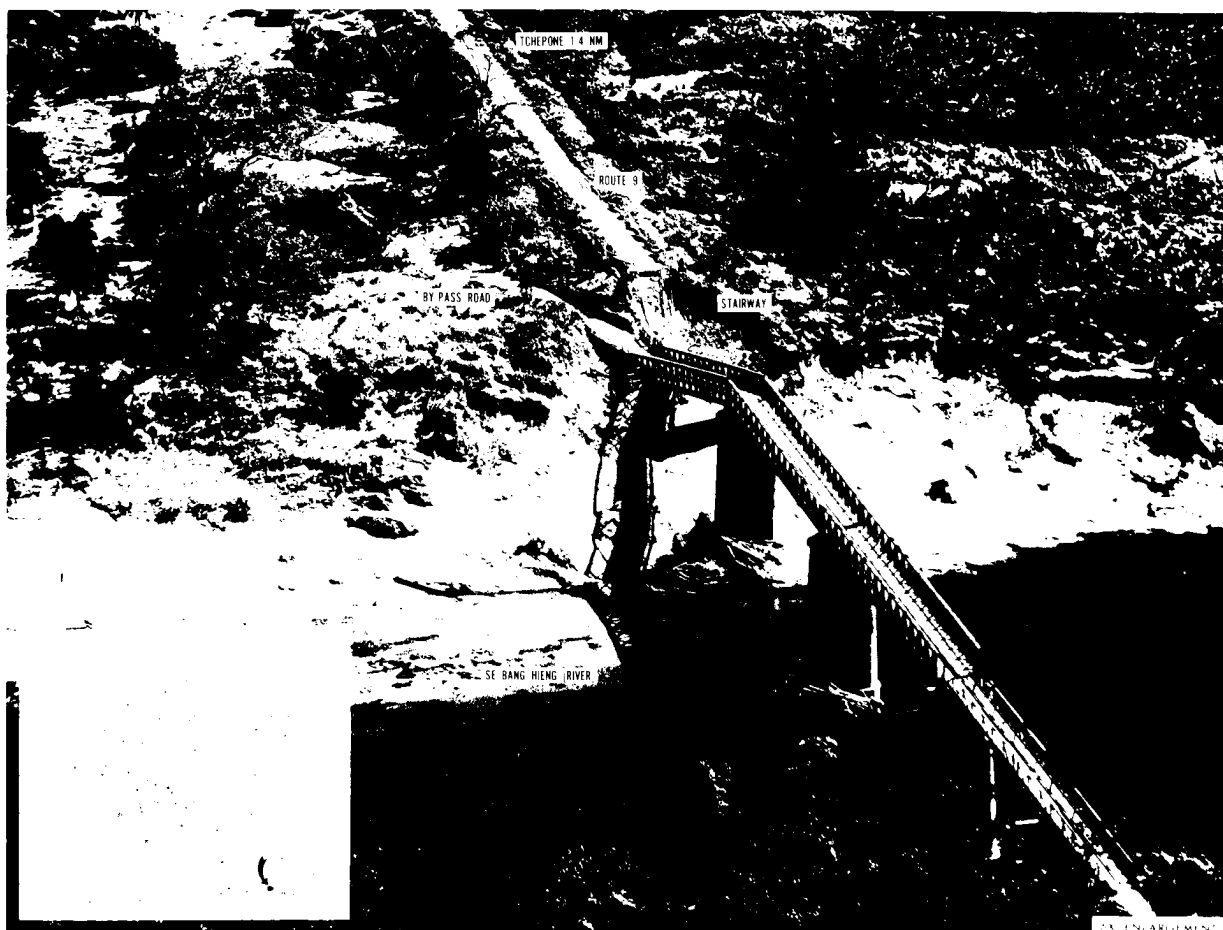
HIGHWAY BRIDGE, ROUTE 9
TCHEPONE AREA, LAOS
16-42N 106-13E

2. [REDACTED] REVEALED THE EASTERN SPAN
OF THE BRIDGE PARTIALLY COLLAPSED. FLOODING ACTION WAS APPARENT ON
BOTH BANKS OF THE RIVER. THERE WAS NO INDICATION OF ATTEMPTS TO FORD
THE RIVER.

3. [REDACTED] REVEALED A NEW ROAD BY-
PASS APPROXIMATELY 0.2 NM EAST OF THE BRIDGE CONNECTING ROUTE 9 WITH
THE PARTIALLY-COLLAPSED EASTERN SPAN OF THE BRIDGE. THE BRIDGE APPEARED
TO BE SERVICEABLE FOR VEHICULAR TRAFFIC.

4. [REDACTED] REVEALS A NEWLY
IDENTIFIED STAIRWAY CONNECTING THE COLLAPSED SPAN WITH ROUTE 9. A
MILITARY AREA 0.5 NM EAST OF THE BRIDGE CONTAINS ONE PROBABLE BARRACKS,
ONE ADMINISTRATION BUILDING, AND ONE SUPPORT BUILDING. NO BOMB DAMAGE
IS OBSERVED.
